EXPERIMENTAL PERFORMANCE OF REINFORCED CONCRETE HOLLOW COLUMNS EXPOSED TO FIRE

ABSTRACT

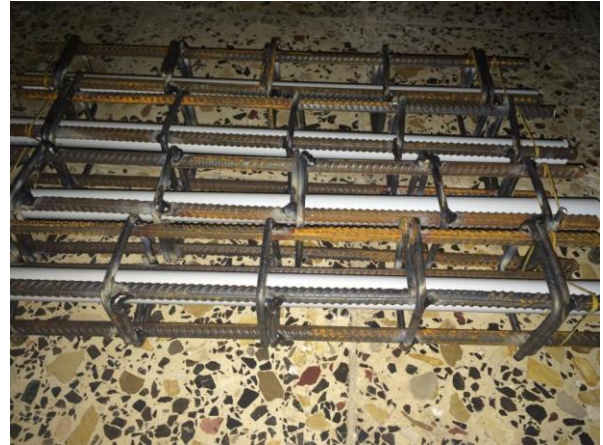
Figure (2): Details of Reinforcement for Column Samples.

(a) Positioning the PVC pipe at the reinforcement cage center

(b) Preparing the reinforcement cage

The specimens of each group were cast in one concrete batch, three standard cubes (150×150×150mm) were taken to assess the compressive strength of batch, **Table (1)**. Before the casting of columns, the PVC pipes were put centrally inside the reinforcement cages as shown in **Figure (2)**. Then, the cages were placed inside wood moulds leaving a clear concrete cover of 10mm from all sides. The columns were casted in the side position. A good compaction was guaranteed using a vibratory table.

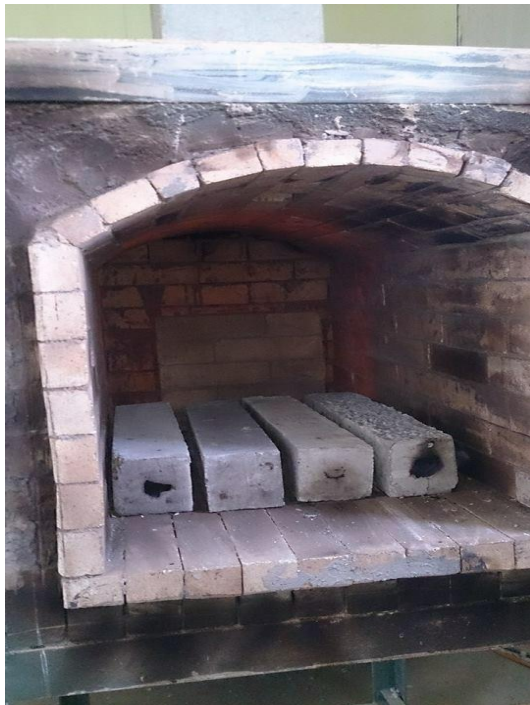
Figure (3): Gradually Cooling of Specimens.

Next accomplishing the burning process, the furnace was turned off and its door was opened. The specimens left inside the furnace to cool gradually as shown in **Figure (3)**. Then, the specimens were taken out, and their surfaces were examined accurately. Cracks distributed randomly were noticed, they became deeper and more numerous for specimens exposed to the higher temperature as shown in **Figure (4)**. Moreover, these samples displayed a concrete cover spalling off, especially at their corners. The burnt columns were kept at a room temperature before the testing.

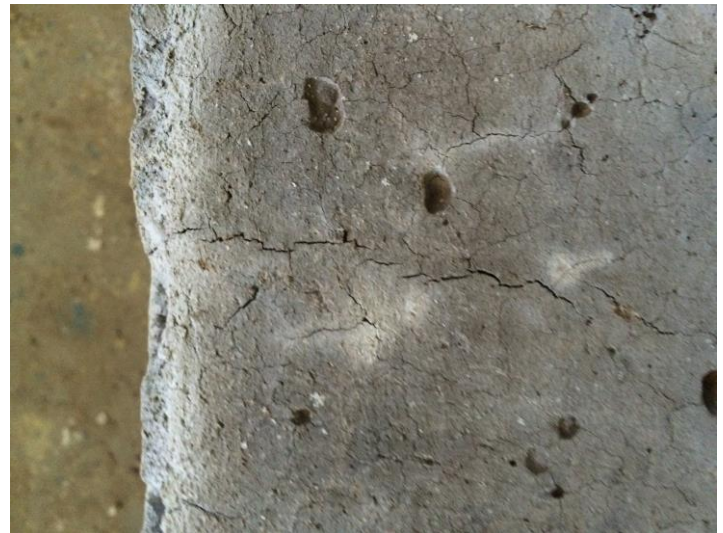
Figure (4): Typical of Fire Cracks Distributed Randomly over The Specimen

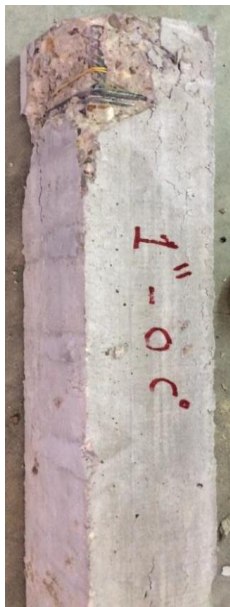
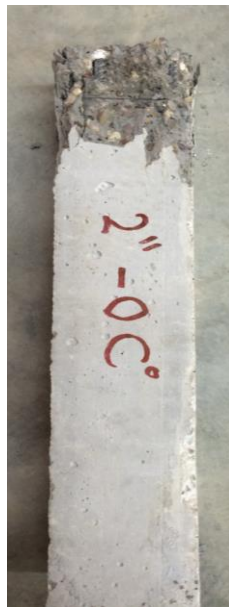
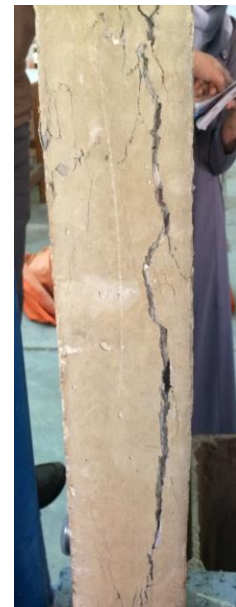
Figure (6): Crack Patterns for Unexposed Specimens.

(a) Column C1-0

(b) Column C2-0

(c) Column C3-0

The unexposed reference samples displayed, firstly, tiny cracks in the outer thirds of their length. The first cracks initiated at loads of 120, 100, 75, and 50 kN for samples C0-0, C1-0, C2-0, and C3-0, respectively; their number, depth, and width increased rapidly as the applied load increased. They developed preliminary vertically parallel to the samples' longitudinal axis, and thereafter they inclined toward the column's corners. At a collapse, the samples experienced a concrete crushing at the

specimen's ends, where the stress concentration was relatively high. On the other hand, the largest hollow size sample, C3-0, spilled longitudinally at collapse load as illustrated in **Figure (6)**.

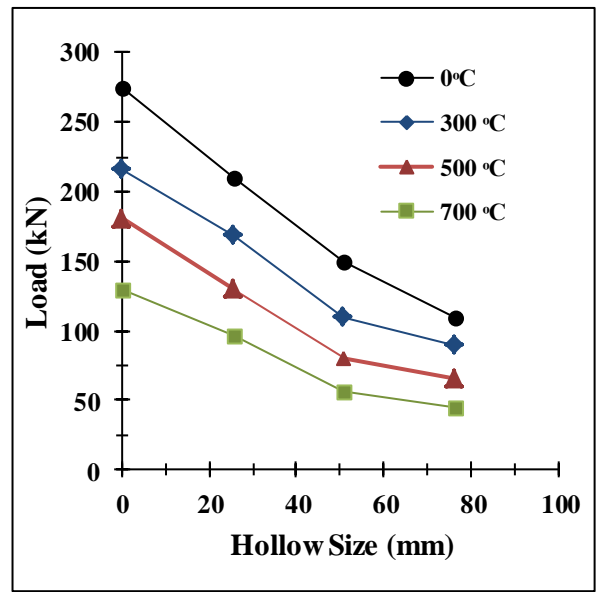
Figure (9): Column's Strength versus Hollow Size.

The failure loads of all four specimens subjected to a same temperature were compared together to evaluate the influence of a hollow size as shown in **Figure (9)**. It can be seen that the column ultimate load decreased rapidly as the hollow diameter increased up to (50.8 mm). Then the reduction rate became slow, especially for specimens exposed to temperature higher than 300 °C.

The drops in the failure load for 25.4, 50.8, and 76.2 mm hollow columns compared to the corresponding solid columns were: 23.64%, 45.45%, and 60.00% for unexposed columns, 21.86%, 48.84%, and 58.14% for 300°C fire-exposed columns, 27.78%, 55.56%, and 63.89% columns burnt at 500 °C, and 25.38%, 56.15%, and 65.38% for columns exposed to 700°C, respectively.
